Femoral head disengagement from Accolade femoral stem in MOM Arthroplasty: a case study and literature review

Mohamed F. H. Elsheikh* and Rehan Gul

Department of Trauma and Orthopaedic, Cork University Hospital, Wilton, Cork, Republic of Ireland

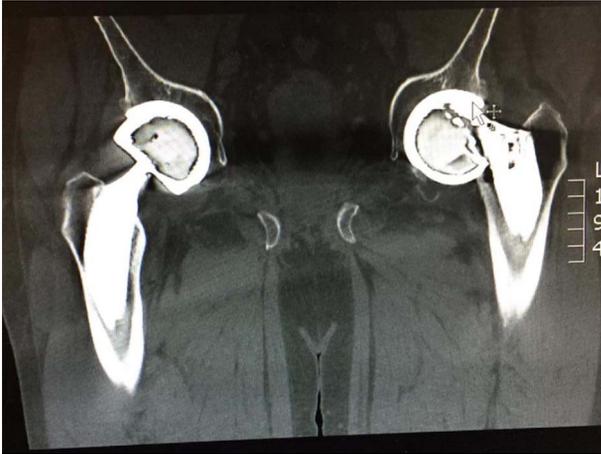
Figure 1. CT scan (Coronal View) showing dislocated femoral head for the trunnion of the femoral neck.

He had been reviewed at the orthopedic clinic afterward, where a CT scan was performed (Figures 1 and 2) which confirmed implant dissociation.

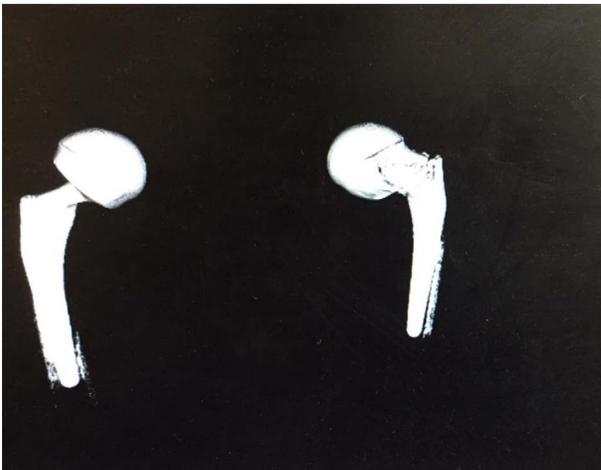
Figure 2. CT scan (3D Construction), showing the dislocation.

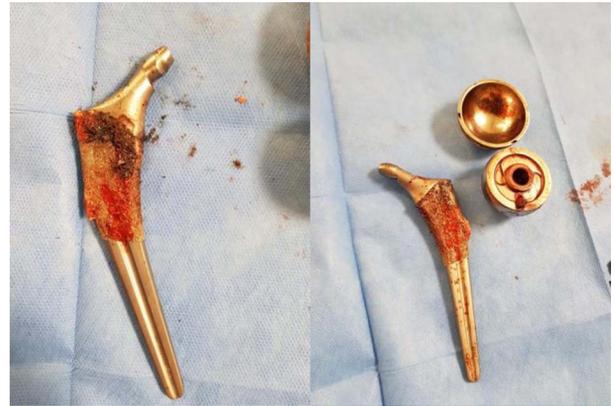
Figure 3. Intra-op pictures of the prosthesis, showing the bend at the neck-taper junction.

The patient underwent revision left total hip replacement. Intra-op findings included: a large pseudotumor around the prosthesis containing metal debris which was excised, advanced

corrosion around the trunnion with deformed shape (Bending at the neck-taper junction, [Figure 3](#)) and disengagement of the femoral head from the femoral stem.

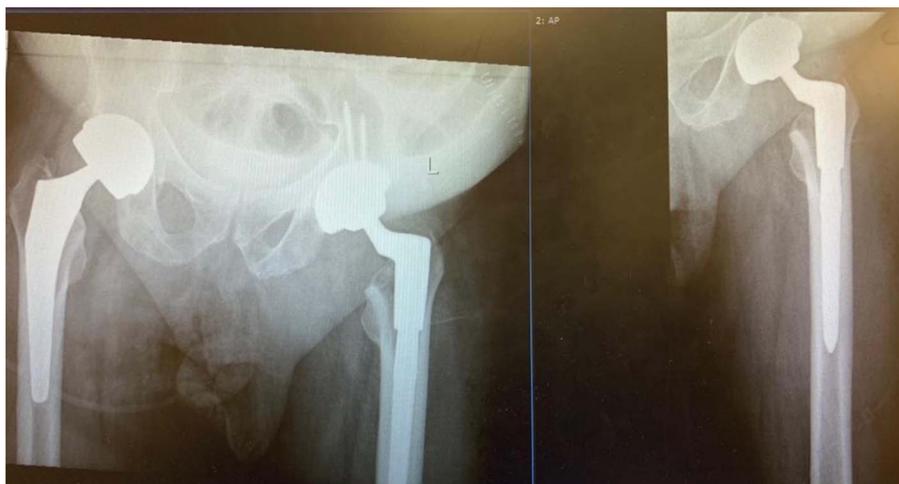
Figure 4. AP pelvis and left hip post-operative check X-rays.

Reclaim conical cementless femoral stem at revision surgery with a pinnacle (Gripton) acetabular shell (Product of DePuy Synthes Company – HQ based in Raynham, USA) was used ([Figure 4](#)).
