## Removal of broken reamer stuck into femoral shaft in implanting PFNA: a case report

Gang-Qiang Jiang, Ya-Di Zhang, and Yun-Qiang Zhuang\*

Department of Orthopedics, Ningbo NO. 6 Hospital, NO. 1059 ZhongShan Road, 315040 Ningbo, PR China

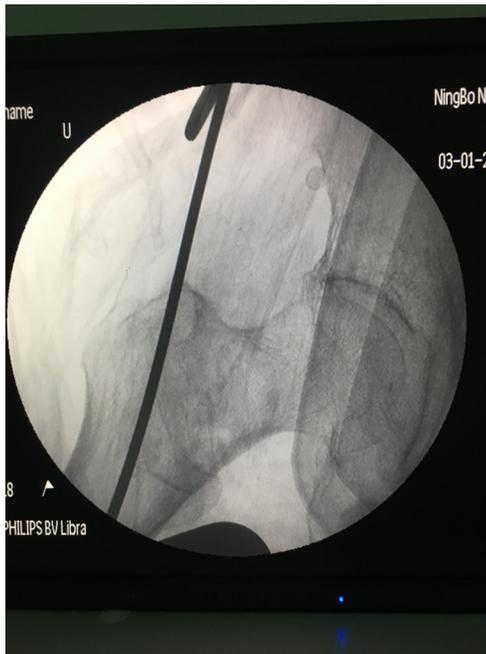
**Figure 1.** After reduction of intertrochanteric fracture, a guide pin was inserted into tip of the trochanter.

point to insert the guide needle (Figure 1). In sequence, reamed medullary cavity was performed step-by-step. Unfortunately, the reamer was stuck into femoral medullary cavity tightly at last, we could not move out by traction or rotation. What's the worst, the reamer head was ruptured completely finally, and remained in femoral shaft isolated (Figure 2). The broken reamer located much more distal to the femoral intertrochanteric fracture site and jammed with cortex of bone firmly. So an extreme tough challenge for removal was in front of us.

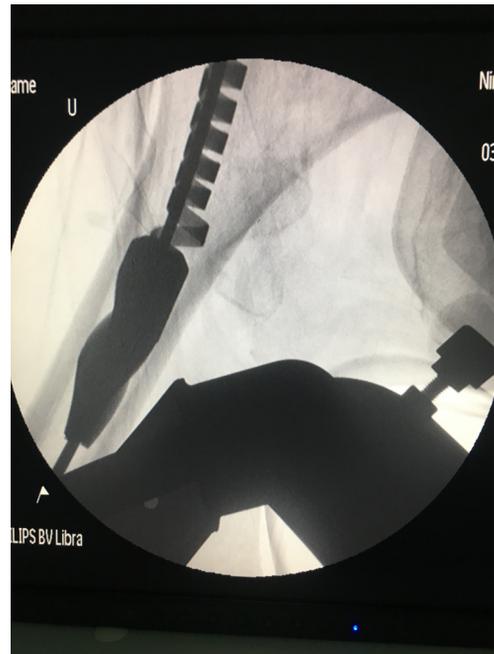
**Figure 2.** The reamer head was broken, then ruptured completely finally, and remained in femoral shaft isolated, it can't pull out just rely on hauling.

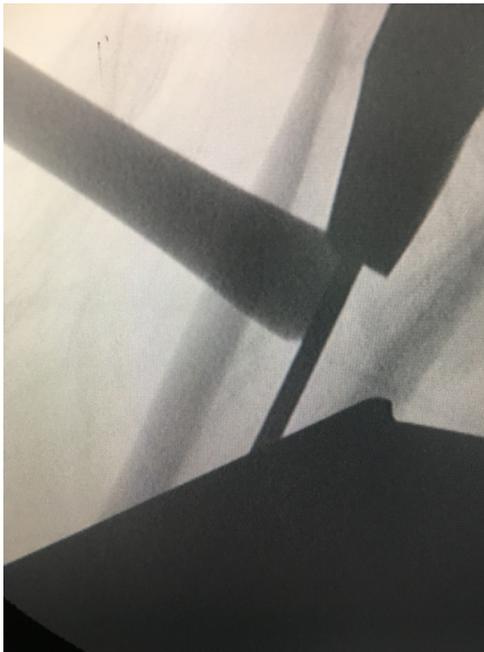
**Figure 3.** A long strip bony window by using an osteotome, which is just right for inserting a bone detacher.

The guide needle was removed easily, on account of less experience to refer, and no instrument to use. Therefore we performed an open technique and created a 2.0 cm × 0.4 cm long strip bony window by using an osteotome, which is just right for inserting a bone detacher, then put the detacher head adjoin the reamer, we moved out the broken reamer head by knocking back the inserted detacher and pulling out through the medullary cavity using a Kocher's clamp (Figure 3). A set of PFNA was inserted to fixation and the bony window was full with bony bar taken down before, and the fracture got a good bone union after 2 months (Figure 4).

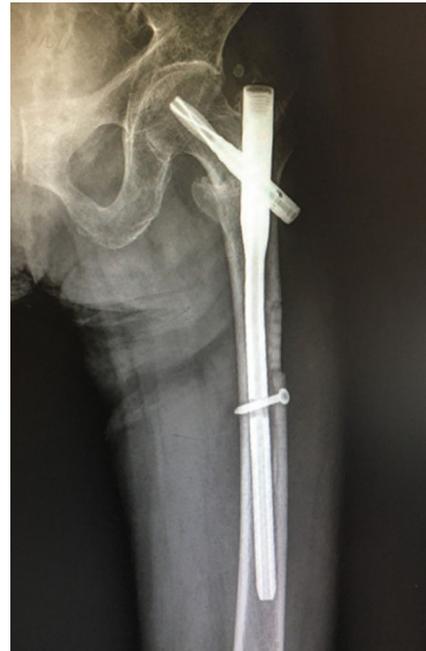
**Figure 4.** The broken reamer was moved completely, and PFNA was implanted.
