Analysis of an explanted dual mobility cup after 21 years, parabolic wear pattern: A case report

Abstract – *Case*: A dual mobility cup was implanted in 1983 in a 43-year woman. After 31 years of normal function, we analysed the explanted materials with modern techniques. *Conclusion*: Volumetric wears of the small and large articulations of the dual-mobility construct were similar. For the first time, we demonstrated that the dual-mobility liner underwent parabolic (not linear) wear during the period of implantation.

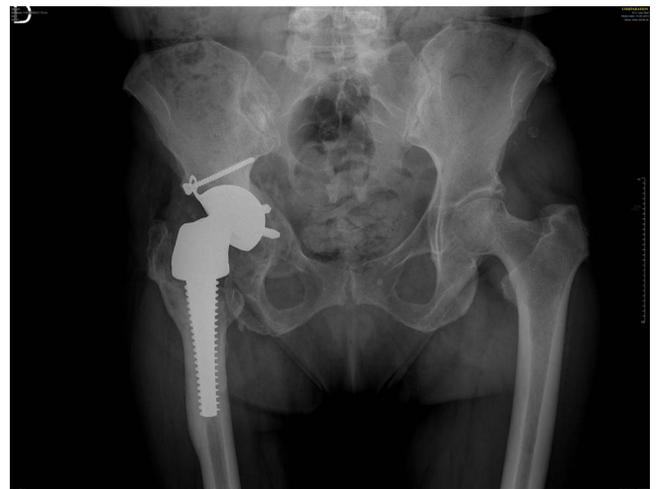
In 2014, cup aseptic loosening was diagnosed (Figure 1) leading to unipolar acetabular revision. The dual mobility cup was explanted and analysed in 2020 with modern, highly accurate analysis methods.

Figure 1. AP view of the pelvis taken in 2014.

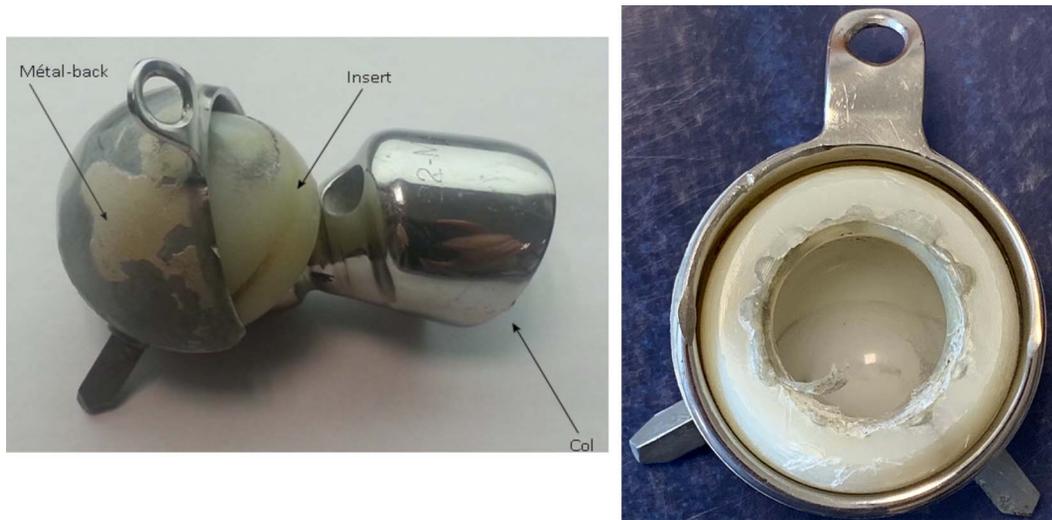
Impingement lesions were found between the prosthetic base and the metal-backed shell causing deformation of the

shell with burrs. However, this did not prevent the PE liner from moving freely inside the metal shell. A circular deterioration pattern due to neck impingement was found around the orifice where the head is introduced into the PE liner. There was no intraprostatic dislocation. On the outer surface, there was a dark band at the level of the anchoring pegs. Residual metal debris was found on the load-bearing areas of the PE liner. A linear notch was visible parallel to the free edge of the PE liner in the load-bearing area.

Figure 2. Photograph of the explant analysed.

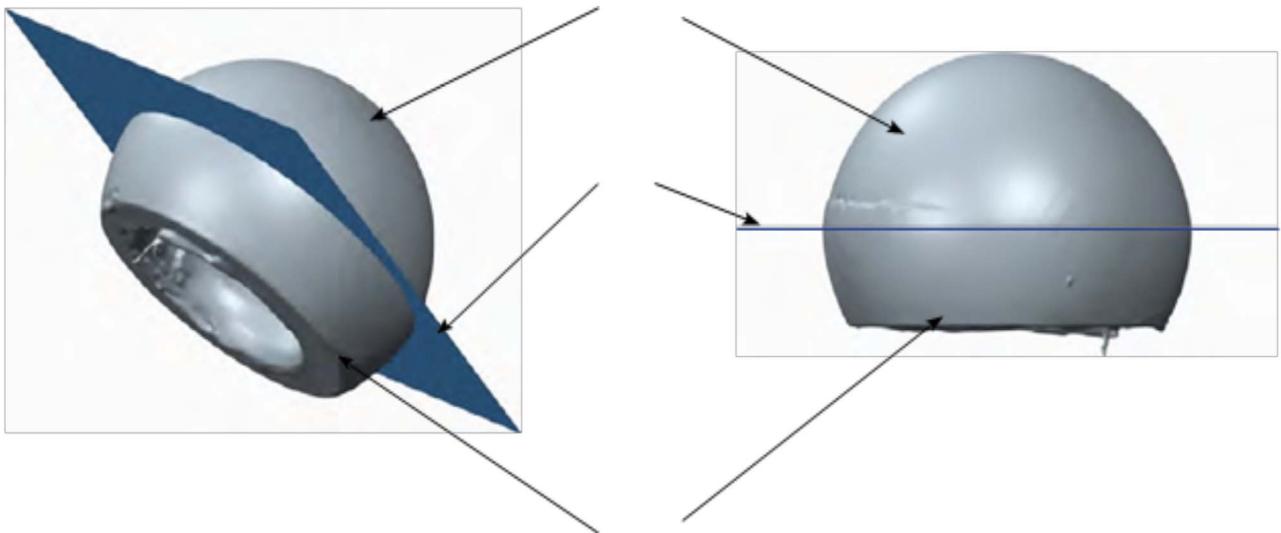
Analysis of the outer surface identified two zones on the liner, separated by a plane parallel to the flat portion of the liner and passing through its centre (Figures 3 and 4). The analysis indicated that the head had migrated a considerable distance towards a new centre, offset by 2.6 mm. The offset angle was 41.6° in the plane closest to the reference plane, which is the liner's free plane (Figure 5).

Figure 3. Plans of study.

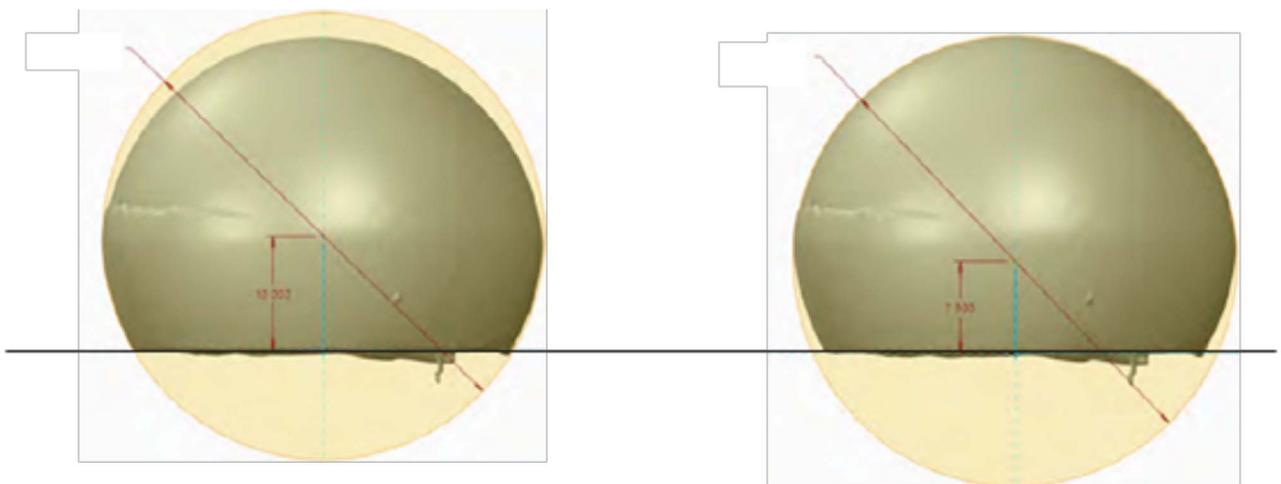
Figure 4. Linear wear of the large articulation was 2.1 mm.

In our case, the linear wear of the small articulation was 2.5 mm (Figure 5) while the wear of the large articulation was 2.1 mm (Figures 4 and 5). In this case, linear wear totalled 4.6 mm over 21 years (0.22 mm per year). Conversely, like in the study by Adam et al. [6], linear wear was similar between the small and large articulations.

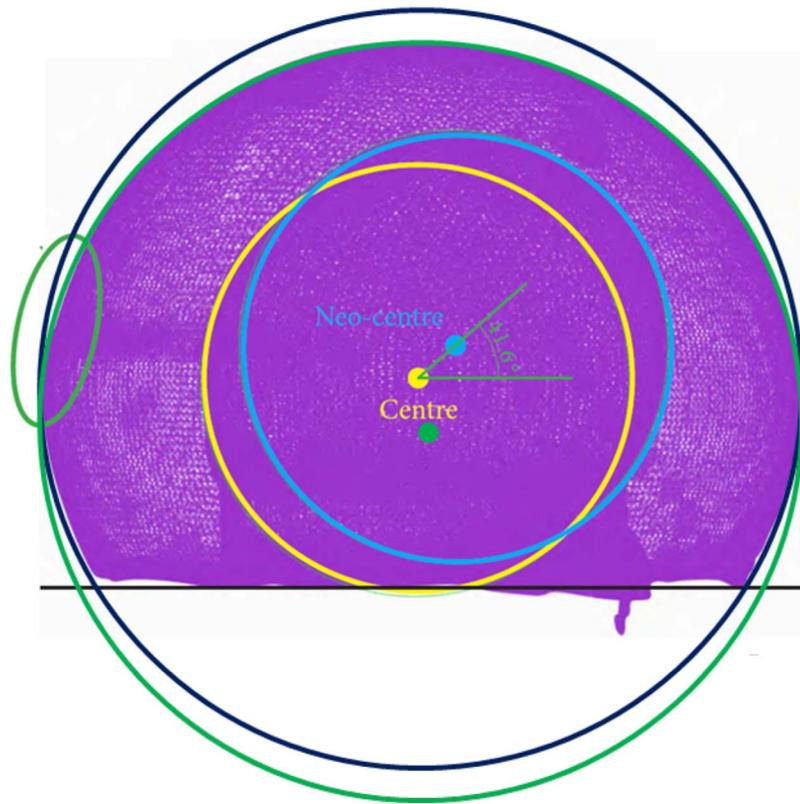
Despite the soft nature of the PE liner, we found the metal shell to have 0 to 1 mm of wear in the load-bearing zone, leading to metal ion release, which may contribute to polyethylene tattooing and increased wear due to abrasion from a third-body effect. The PE liner was damaged by a slight protrusion of the peg, causing a circular notch (Figure 5).

Figure 5. Internal (2.5 mm) and external wear (2.1 mm) of the polyethylene liner. Liner centre (in green), native head centre of the construct at the implantation (in yellow), and new head centre of the explant after wear (in blue).

At the time of implantation, the centre of rotation of the cup, head and PE liner are all superimposed (Figure 5, yellow point). However, these three centres shifted over time: the centre of the cup did not move; the centre of the head followed a parabolic path if the PE liner is considered as a frame of reference (Figure 5, blue point); the centre of rotation of the

PE liner shifted downward along the trajectory of the resultant of the loads placed on the hip (Figure 5, green point).

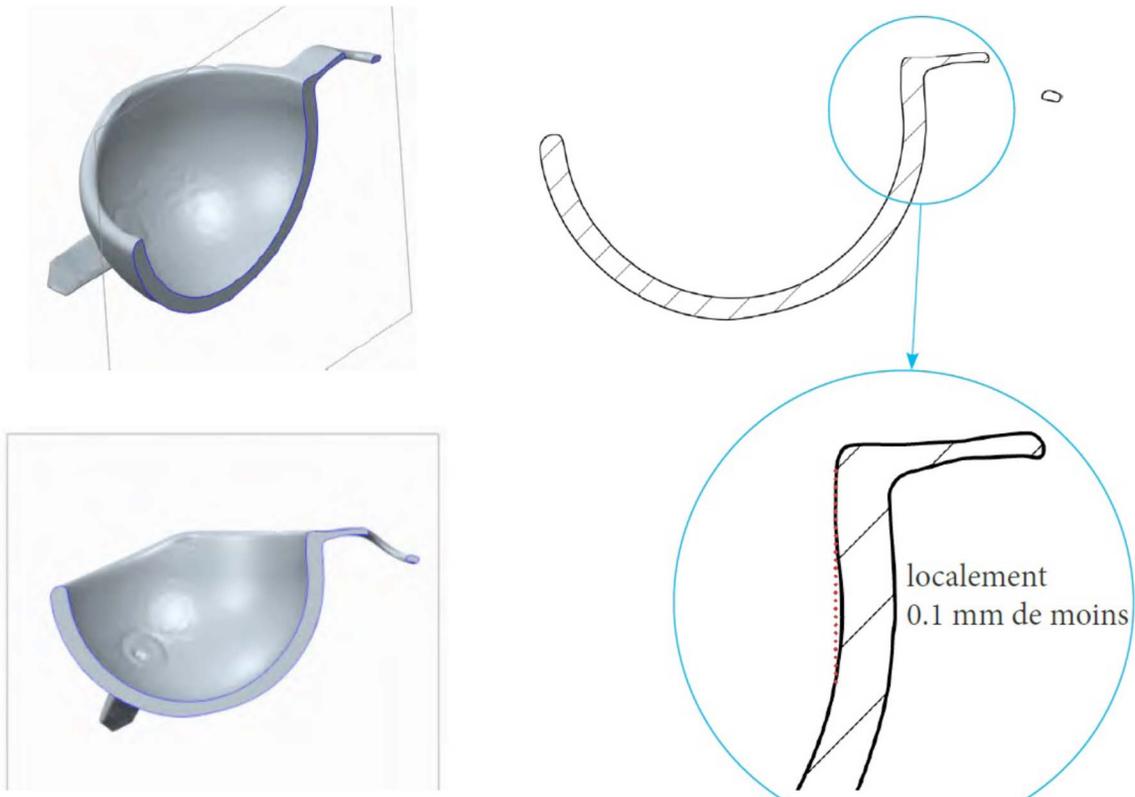
PE liner caused deformation of the shell at the equator. This deformation was in the area when the stresses were the largest (Figure 6). An area of friction was found at the inferior left peg and may explain the stripe deformation observed on the lower portion of the liner (Figure 5). The periphery of the shell was deformed, with two flat spots caused by impacts between the neck and shell. The largest deformation was on its posterior side. This deformation created a burr inside the shell, which likely contributed to liner wear in this area (Figure 7).

Figure 6. Wear of the metal-backed shell.

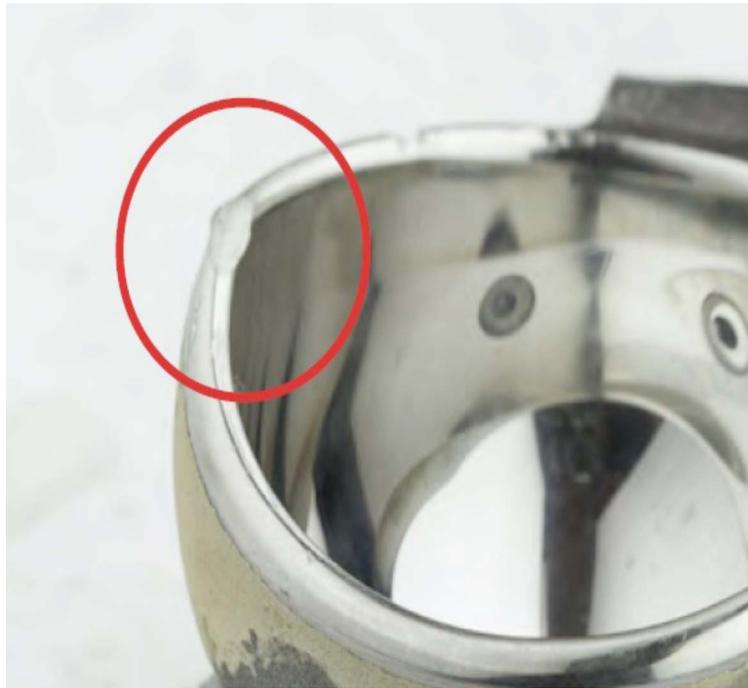
The periphery of the cup was damaged due to impingement with the neck. This can be explained by the hemispheric cup's overhanging design, but also by the poor relationship between the head and neck of the femoral stem, since the base is relatively bulky in this model (16 mm diameter) resulting in a head-to-neck ratio of 1.37 given the 22-mm head. This impingement undoubtedly contributed to the implant shifting, which initiated loosening.

Figure 7. Impingement of the neck on shell.

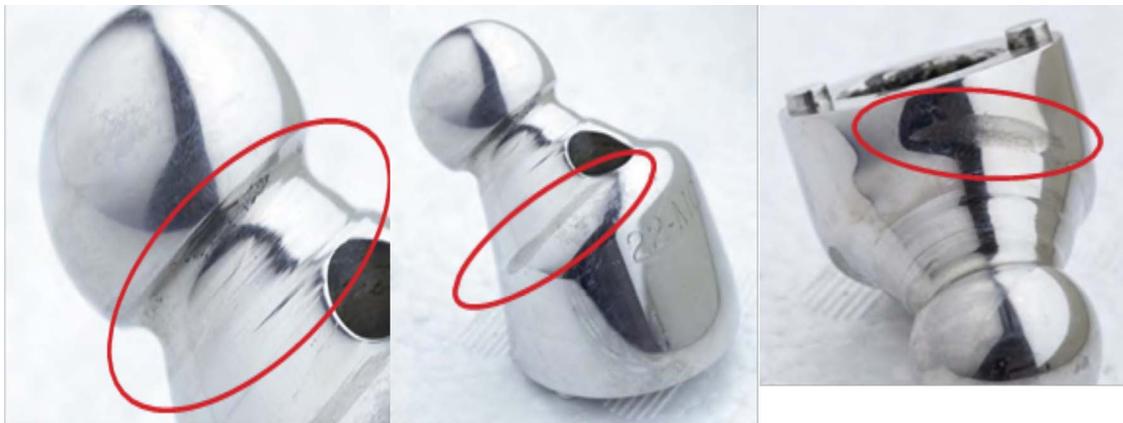
The head was no longer spherical. The mean diameter of the sphere was 21.6 mm (0.4 mm wear). Three areas on the neck were deformed (Figure 8). The first was below the head, near the impaction hole, where the neck rubbed against the liner as the head rotated within the liner. The second area was located on the superior and posterior edges of the neck. These marks correspond to impingement between the neck and shell during extension. The repeated impact created a burr on the shell. The last area was located under the head on the anterior side of the neck. These marks correspond to impingement between the neck and shell during hip flexion (seated position) and generated a flat spot on the metal shell.

Figure 8. Deformations found on neck.

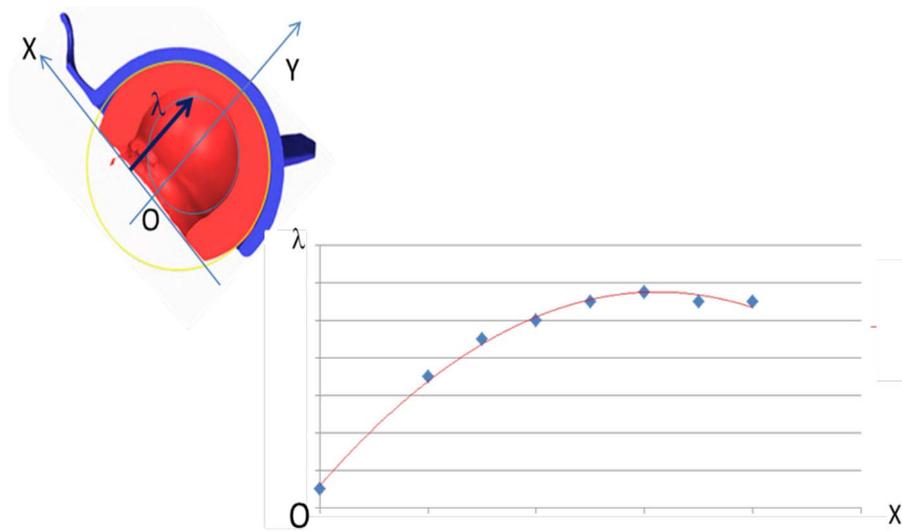
The wear of the small articulation was not linear, contrary to the findings with standard fixed-cup designs. A more precise analysis of the small articulation showed that its wear followed a parabolic curve, which started to erode the retaining zone from the inside (Figures 9 and 10).

Thus, it appears that wear of the retaining zone was triggered by impingement with the prosthetic neck, but also by progressive subluxation of the PE liner during parabolic wear of this small articulation. This is an original and brand-new finding.

Figure 9. Wear is parabolic, not linear.

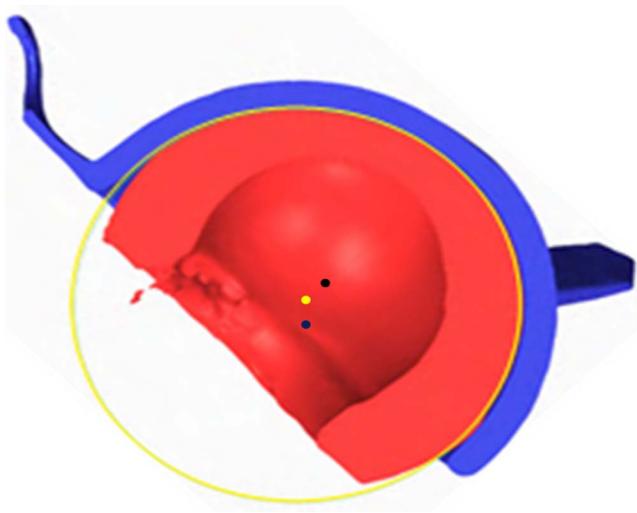
Figure 10. Shifting of the centres of rotation (yellow dot: cup's centre of rotation, black dot: head's centre of rotation, blue dot: liner's centre of rotation).

Figure 10 shows the configuration in which the liner and shell should have been when they were explanted, versus the configuration in which we found them.
